Brief Valuation Report

Address: Sample Street XX in ZIP Sample City

Property Type: Multi-Family House
Residential Units: 5
Living Area approx.: 265.00 m²

Property Inspection Date: 20.01.2025
Valuation Date: 20.01.2025
Quality Reference Date: 20.01.2025

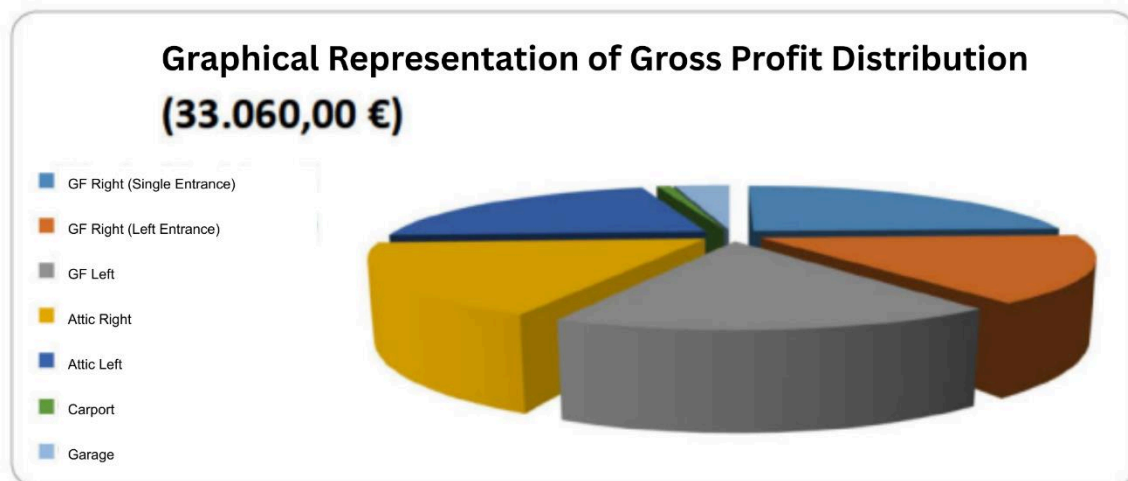
The following graphic shows the distribution of gross income among the individual rental incomes:

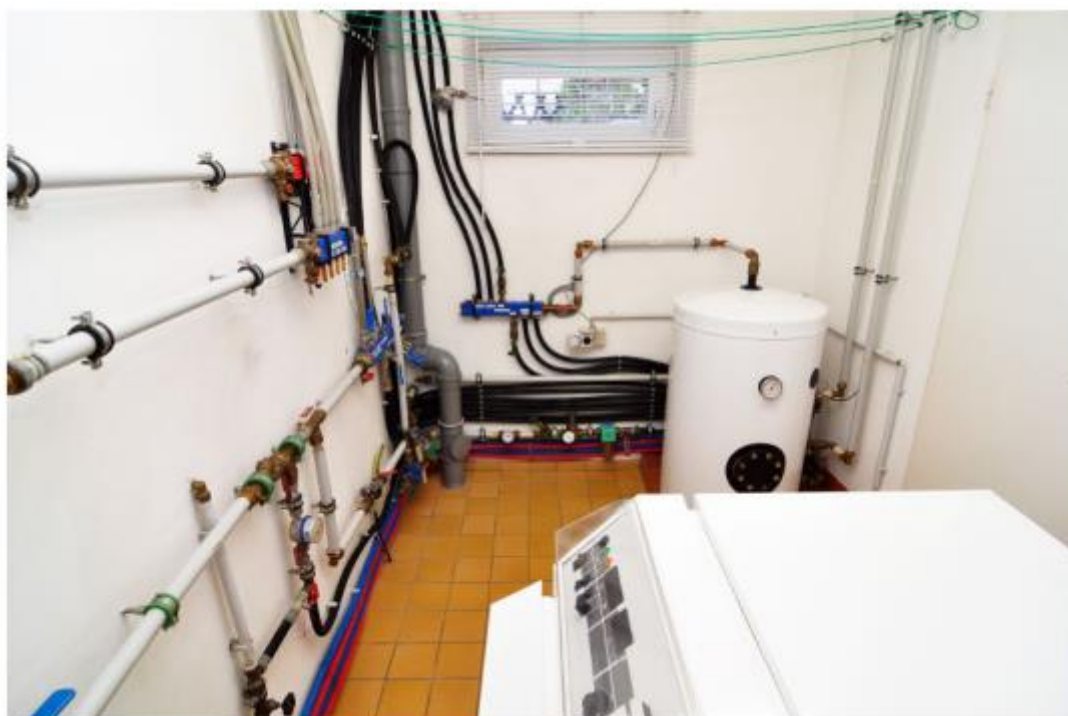
Photo 10 - Heating System - Sample Street XX, ZIP Sample City

Built-in Kitchen(s):	There are built-in kitchens that are assigned to the building.
Hot Water:	Gas heating, year of installation 2018
Heating:	The property is heated by means of a gas central heating system.
